Repair of the ESA-Haystack Radiotelescope

Joachim Köppen

Observatoire de Strasbourg

Jan. & June 2013

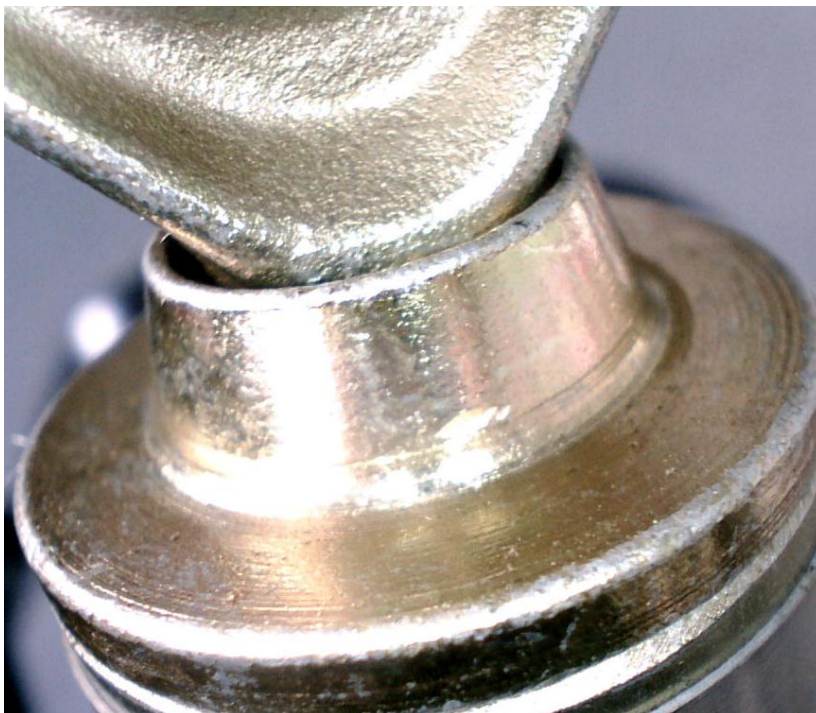
While the manufacturer claims that the actuator is maintenance-free and thus needs no lubrication, it appears that the origin of the problems is that rainwater can easily enter the interior of the actuator via the small gap at the top near the swivel stud (shown in Fig.1).

Fig.1 *The swivel stud at the top of the linear actuator is surrounded by a gap through which rainwater may enter the inner workings of the device.*

In the following years, some oil was regularly applied to the top of the actuator tube. Although this continued to wash out more of the lubricant, it has resulted in a faultless operation of the telescope.

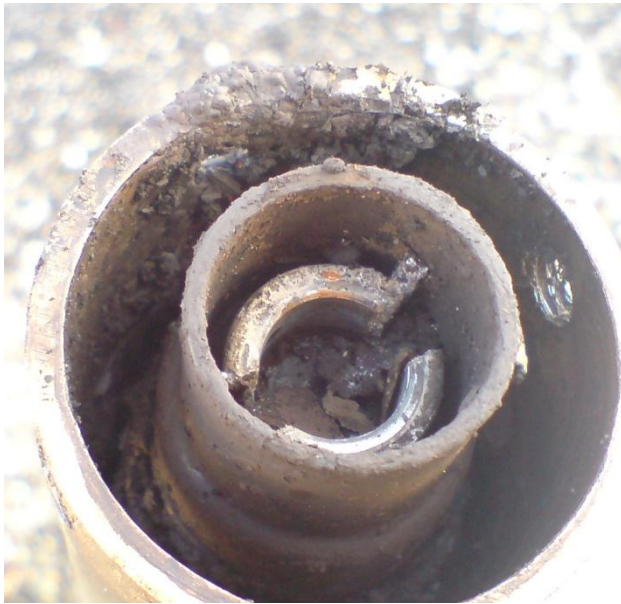
This also led to the washing down of the lubricant, which was apparent as black residue deposited at the bottom end, near the motor housing. Fig.2 shows the situation in 2013

Fig.2 At the bottom end of the linear actuator tube a substantial amount of black residue was found in Jan.13, which appears to be mixture of the original lubricant, the applied oil, and perhaps metal rubbings.

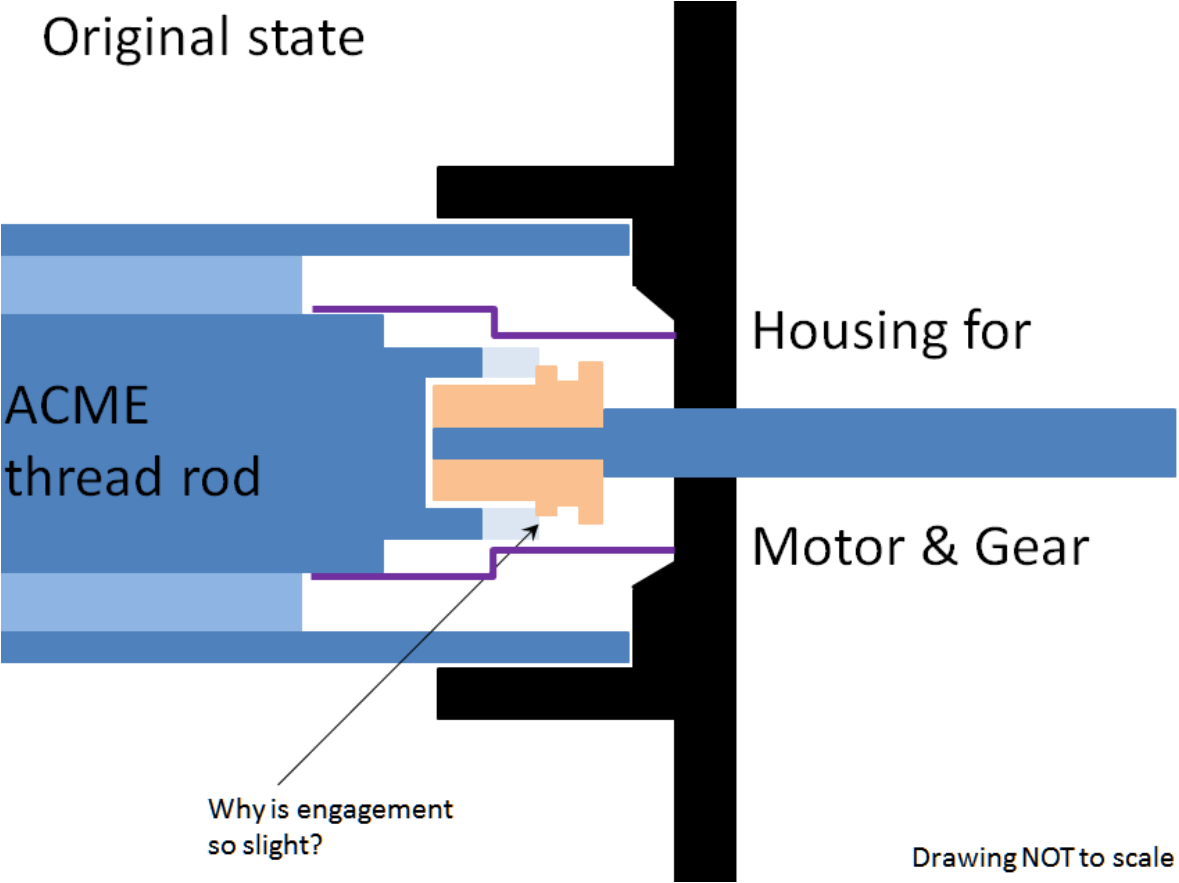
coupling, because its two teeth did no longer engage in the appropriate slots of the threaded rod. The rather small teeth showed heavy wear.

Fig.3 Details of the coupling of the doubly flattened motor shaft to the linear actuator threaded rod. The brown part is the aluminium coupling ring, whose teeth engage slightly in the slots in the walls (light blue) of the threaded rod. The violet part is the plastic tubular cover.

During the careful inspection to unravel and understand the inner workings (Fig. 3) of the linear actuator it was also realized that the teeth of the coupling ring never went very deeply into the slots, although the latter are rather deep (about 5 mm). It may be estimated that the teeth had only a fraction of a millimetre of contact with the slots. This appears a rather strange design!

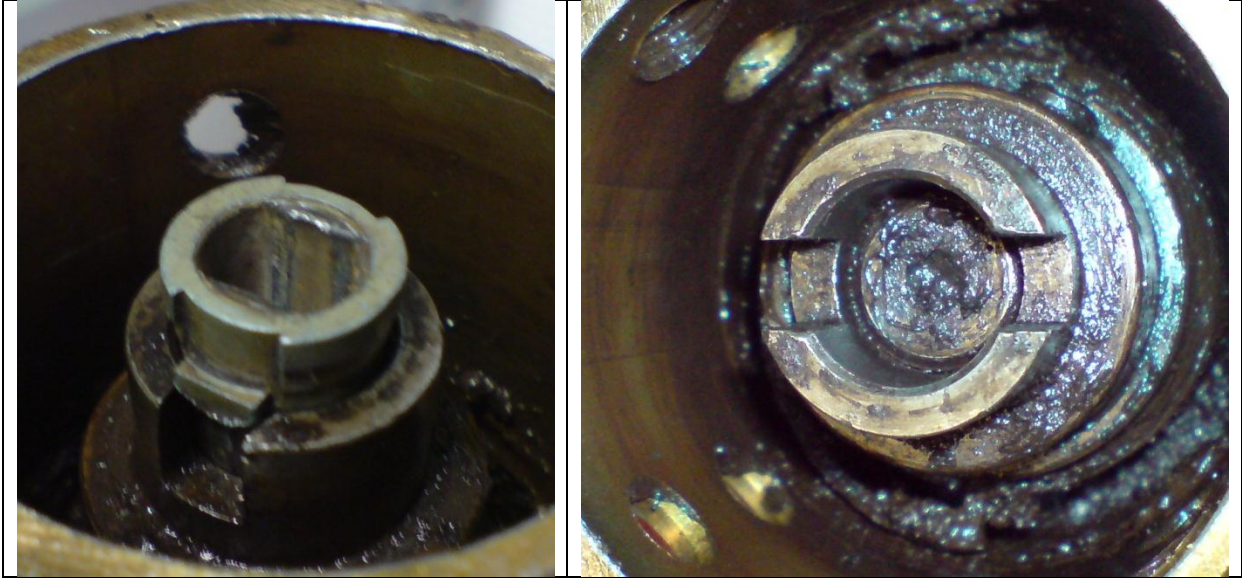
Fig.4 In the original state the coupling ring's teeth engage with the slots of the threaded rod only lightly (left). **Fig.5** The slots are much deeper than the teeth can reach (right).

The absence of engagement of the coupling ring and the threaded rod thus is the reason for the non-functioning of the elevation drive, while the rotation counter – which counts the rotations of the motor axle but not those of the threaded rod itself – would not reveal any fault or error message. The heavy wear on the teeth (Fig.9) is witness that this kind of slipping had already occurred earlier and is responsible for slips in elevation noted in some data.

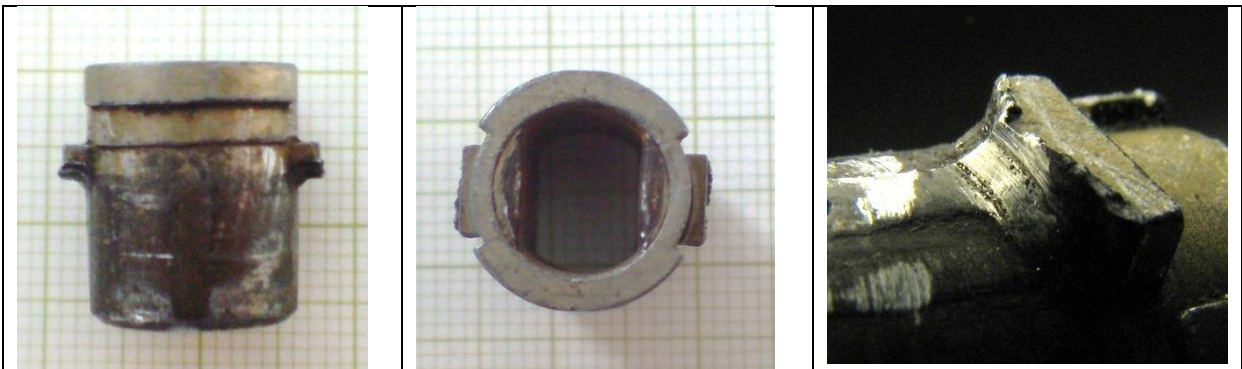
Fig.6 The coupling ring (original state) viewed from the side (left) and the top (centre **Fig.8**). The lower part of a tooth shows heavy wear, while the top side is untouched (right **Fig.9**).

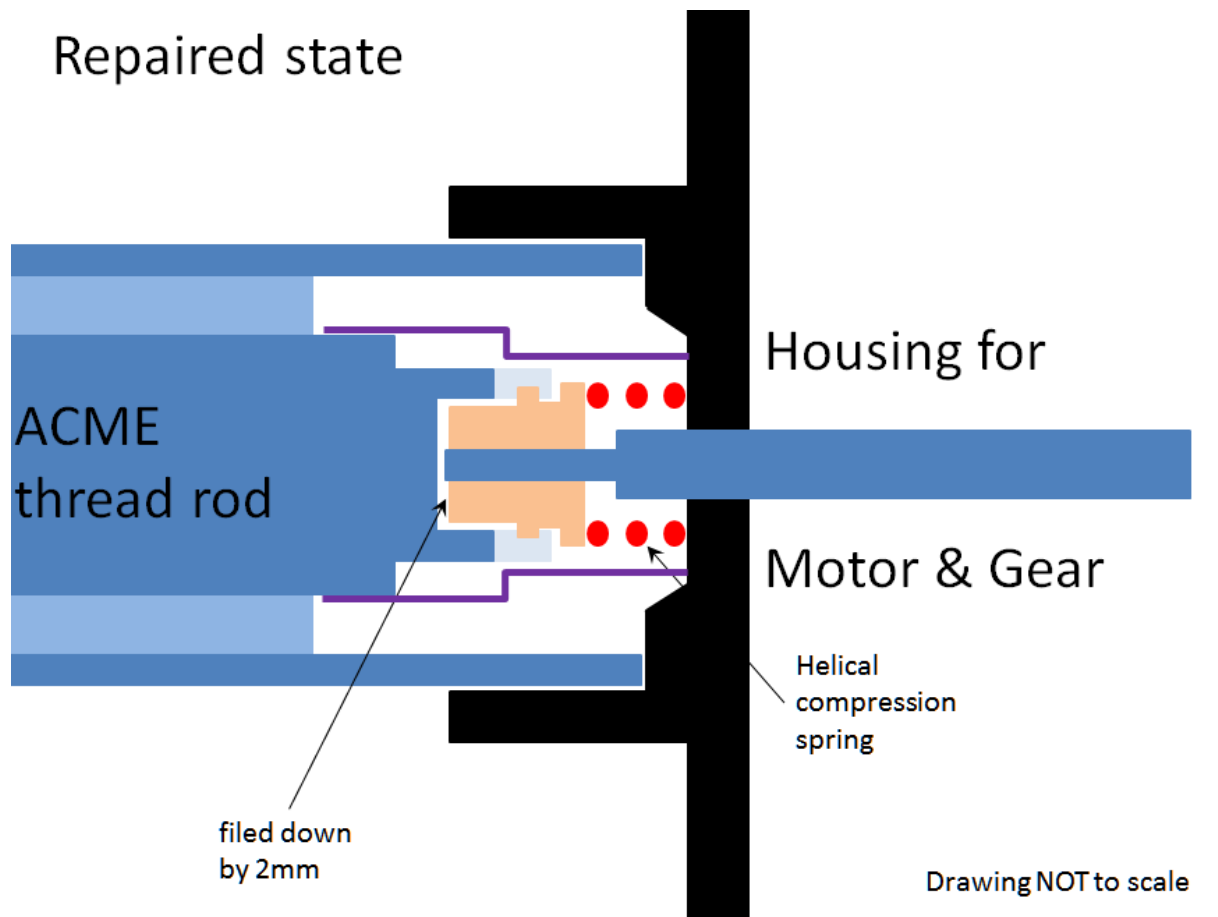
Fig.10 *The coupling of the motor and threaded rod, after modification.*

As the coupling ring's bottom would sit flush in the opening of the threaded rod, which places the teeth too high to engage with the slots, it was decided to file away about 2 mm from the bottom end. The altered situation is shown in Figs.10 and 11. The deeper sitting teeth guarantee full coupling of motor and threaded rod.

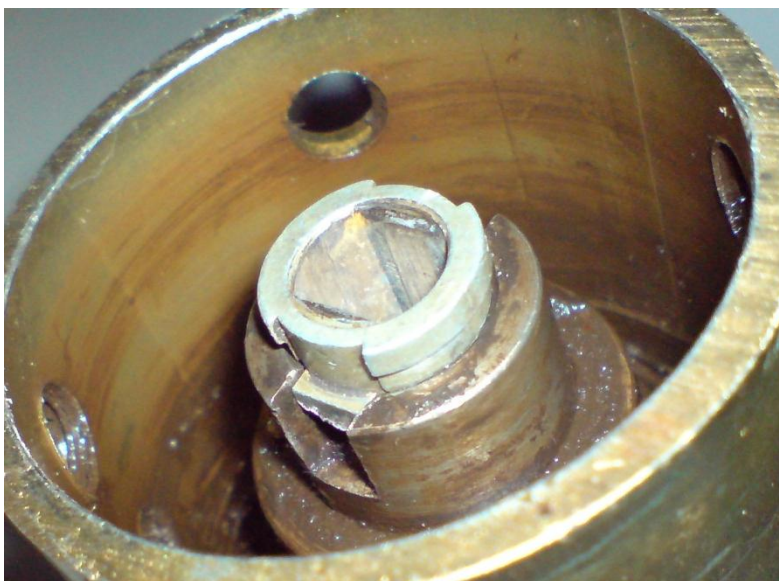
Fig.11 *The reduced coupling ring now engages fully with the threaded rod's slots.*

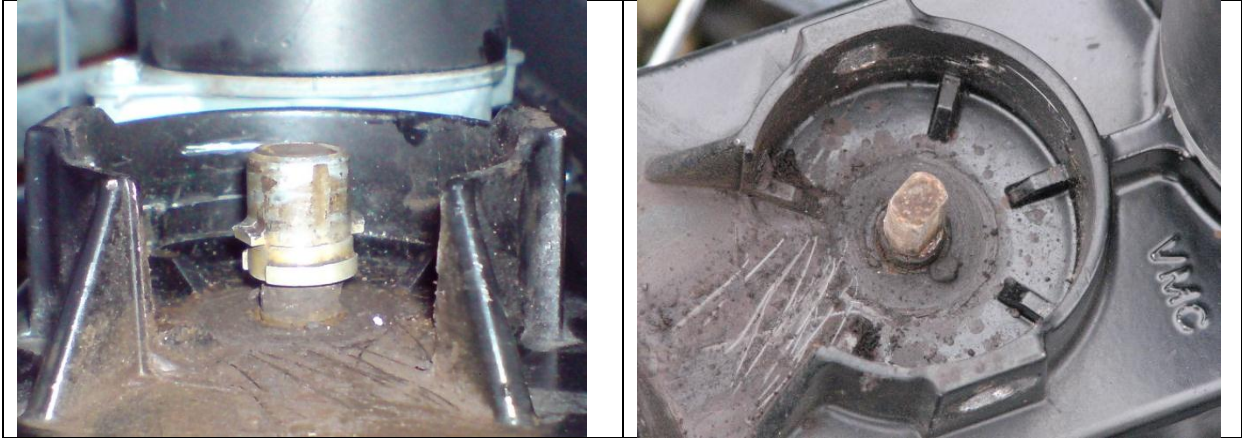
Fig.12 View of motor housing with the receptacle for the actuator rod, and the motor shaft (with the coupling ring in original state: left). **Fig.13** (right) the motor shaft is flattened on two sides to receive the coupling ring and hold it at proper height.

Since in the original arrangement the coupling ring is held in position by the flattened part of the motor shaft (Fig.12), in its shortened form it needs to be pushed towards the threaded rod's receptacle. This is done by a compression spring of suitable dimension, made from a large paperclip. The spring need not be under tension, as it is sufficient to hold the coupling ring at proper position but without rubbing into e.g. the plastic wall of the motor housing due to the shaft rotation.

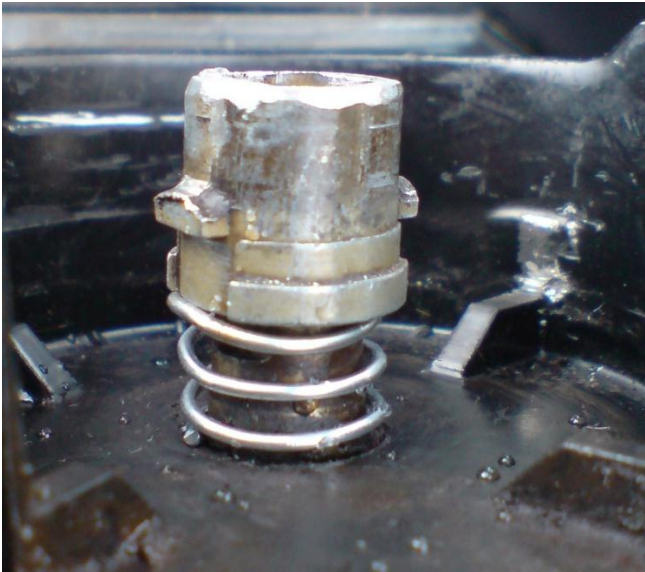
Fig.14 The reduced coupling ring is held up by a small compression spring.

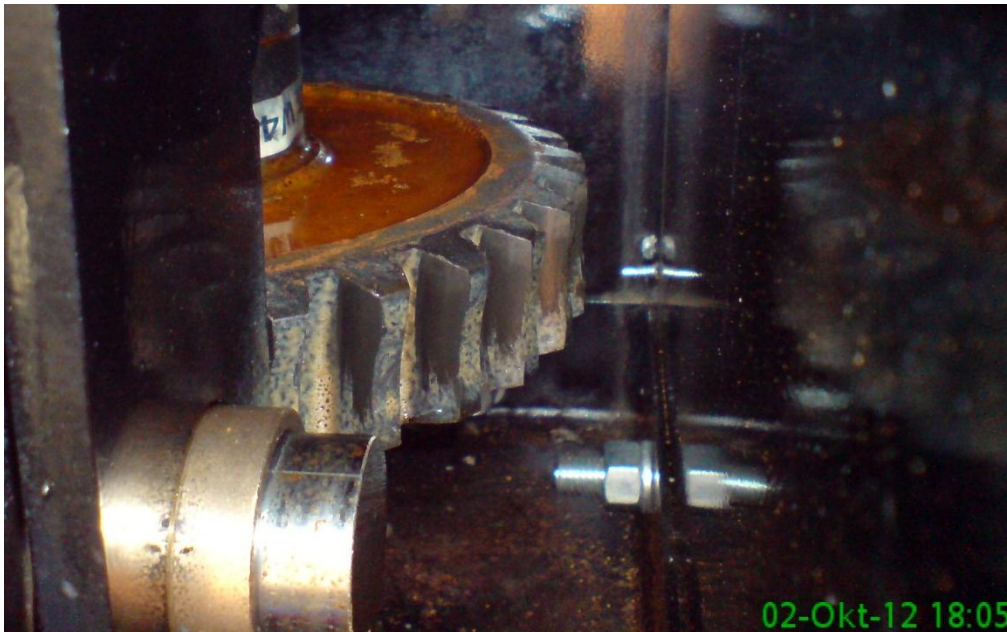
One of most striking things that appear when one opens the motor box is often the presence of plenty of water which fills the upper side of the big azimuth gear wheel:

This is rainwater that seeped into the box through the vertical shaft's bushing at the top of the box, but mainly via a hole just below the bar that constitutes the elevation axis created by the large

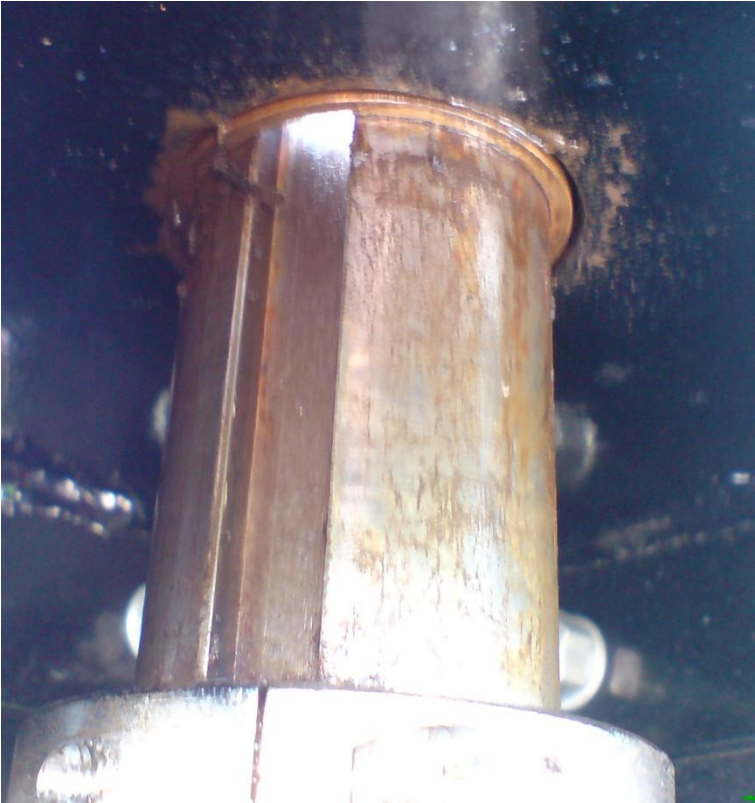
groove which runs all along the vertical shaft, and which was not fully closed by the welding to the horizontal bar. This view was taken when the outer collar of the bushing had been removed:
